# CARRICK on SUIR TOWN WALLS WORKS 2014

COMPLETION REPORT 2014

November 2014

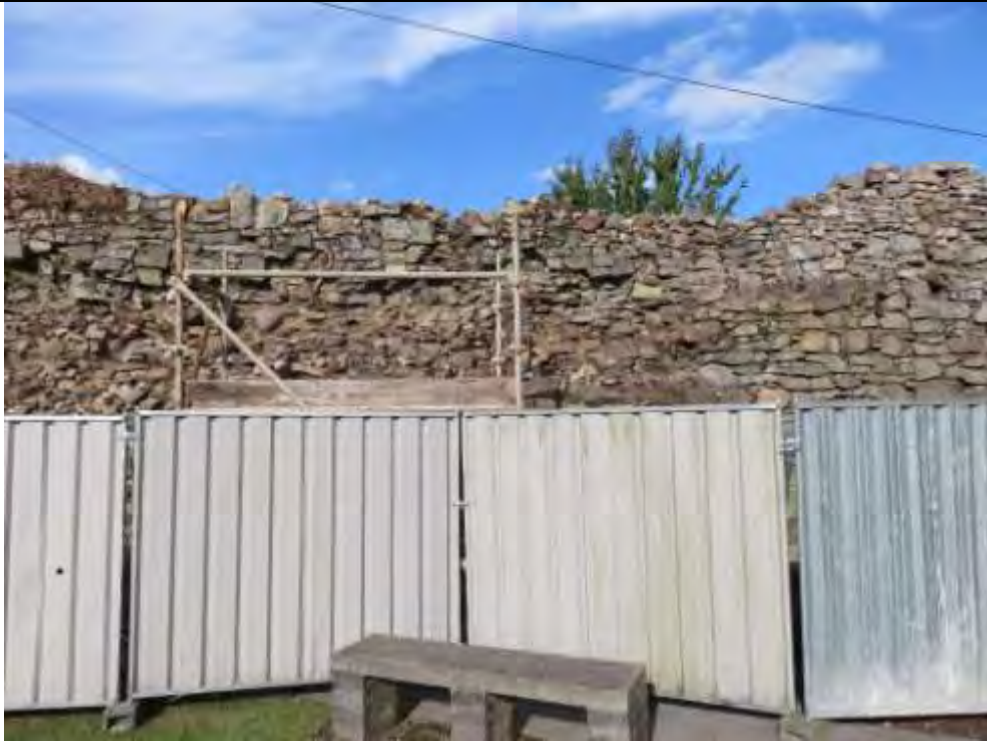
Fig. 11) A view of the south face of the wall following removal of the overgrowth.

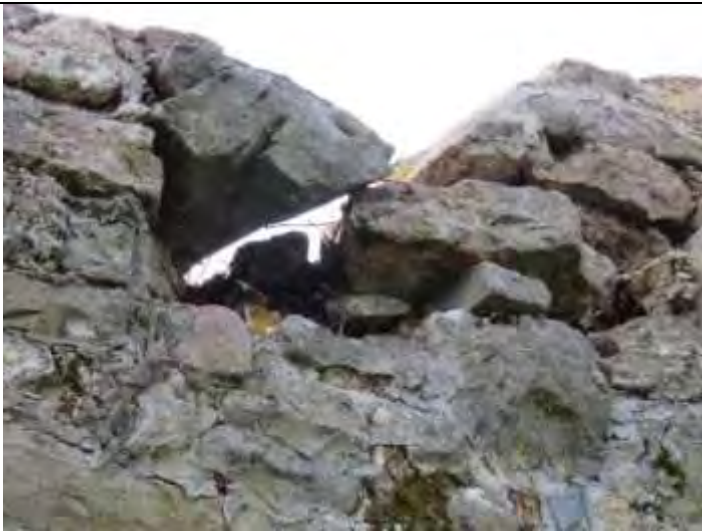
Fig. 14) Precarious masonry just resting there.

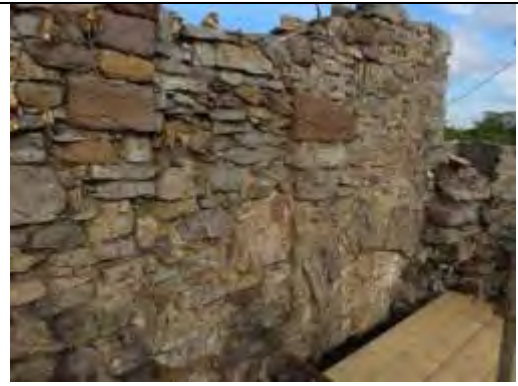
Fig. 15) A section of a previous ope now blocked up.

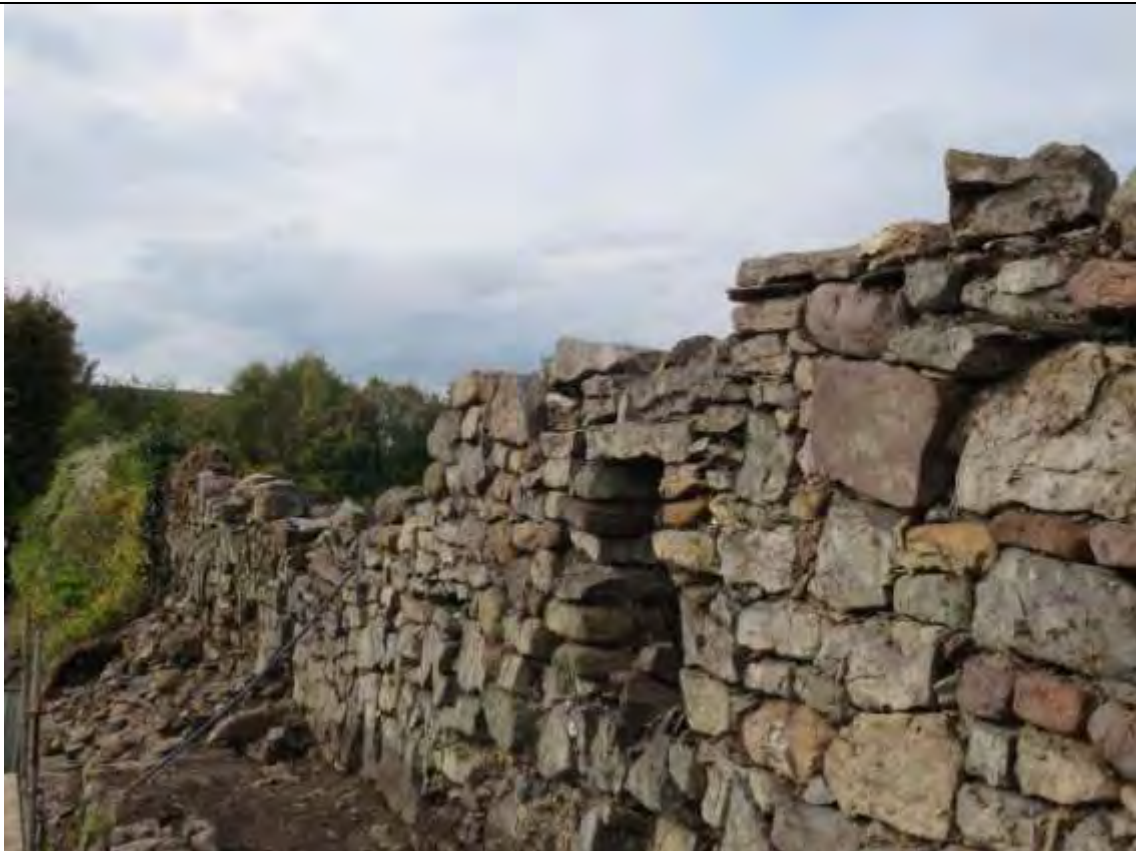
Fig. 16) The south face of the wall and wall-walk is really now a dry stone wall

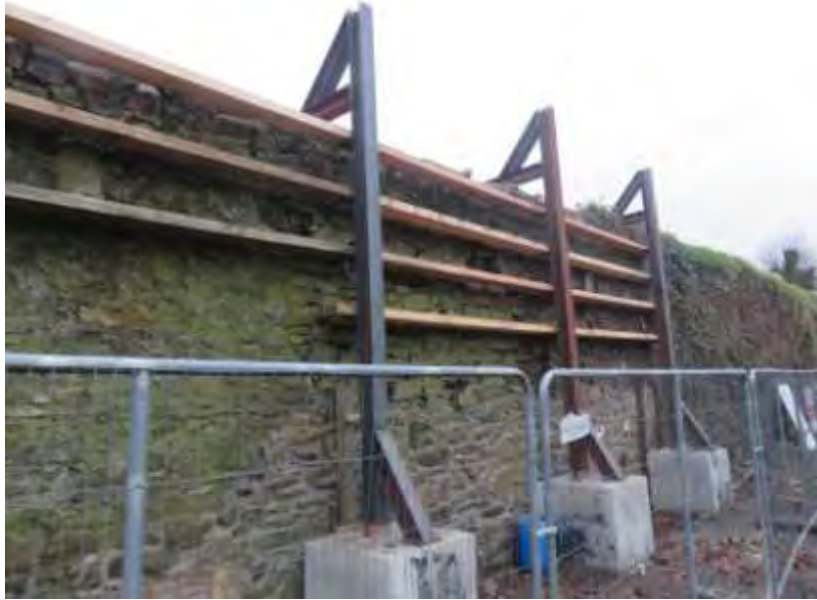
Fig. 17) The temporary shoring erected to the north elevation.

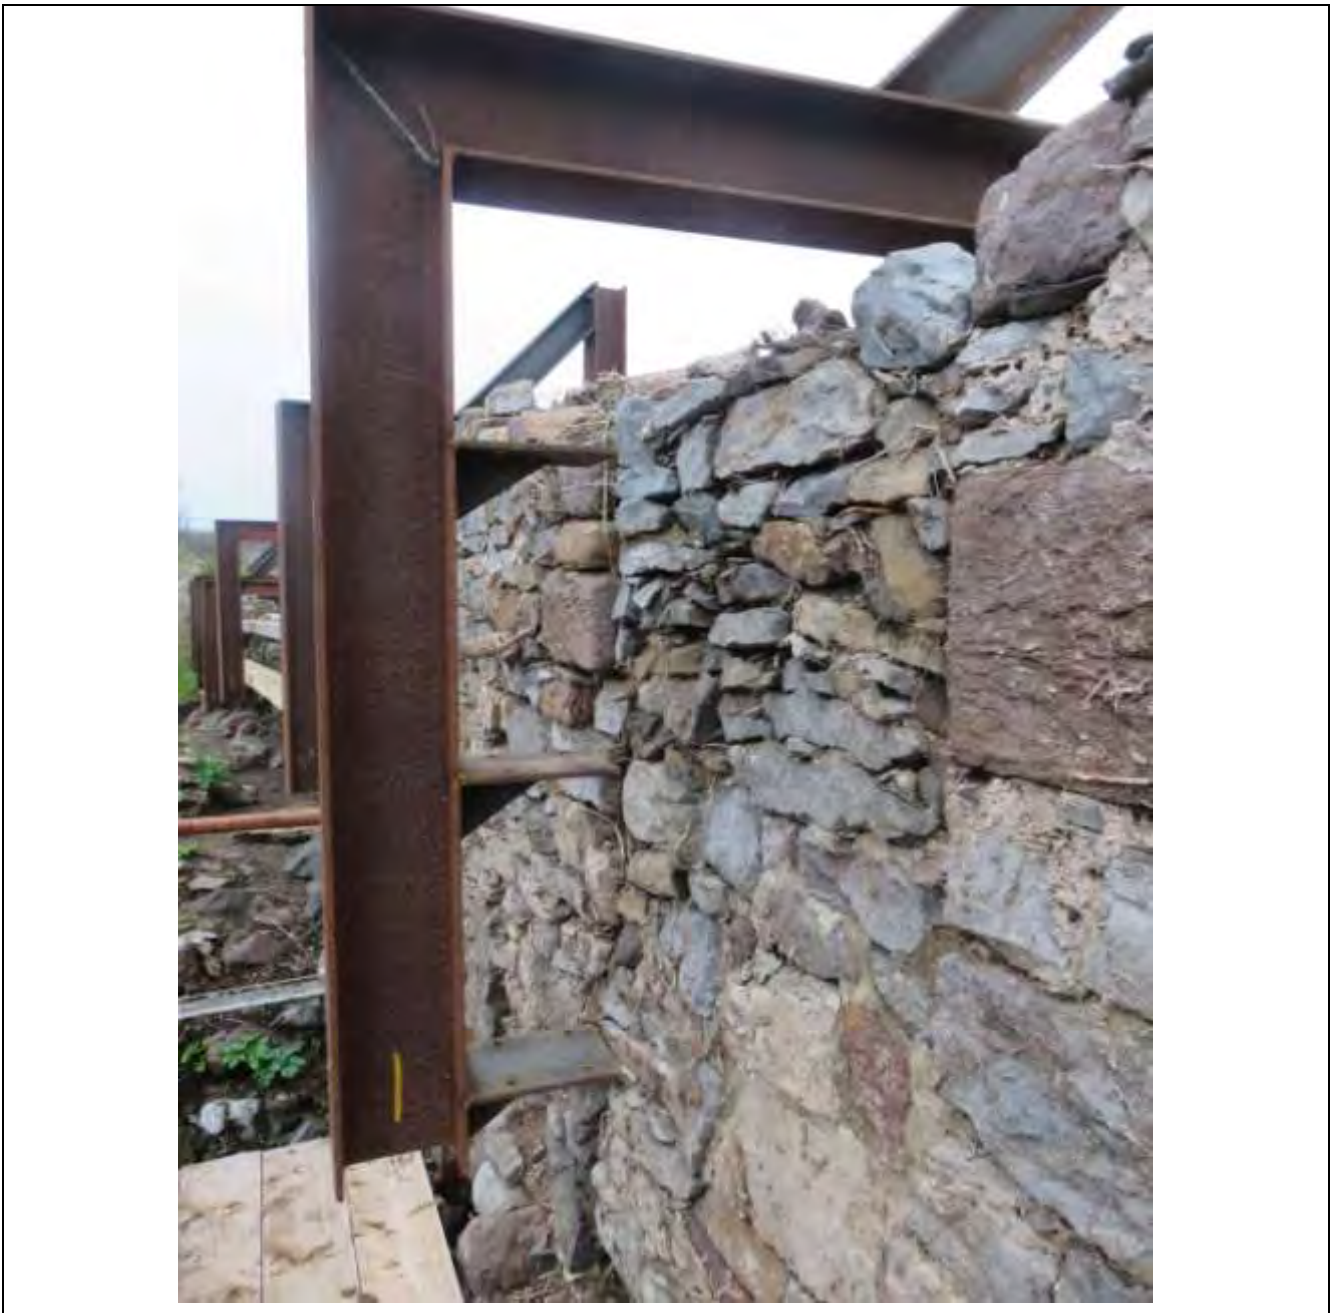
Fig. 18) The metal beams wrap over the wall to give support to the south elevation

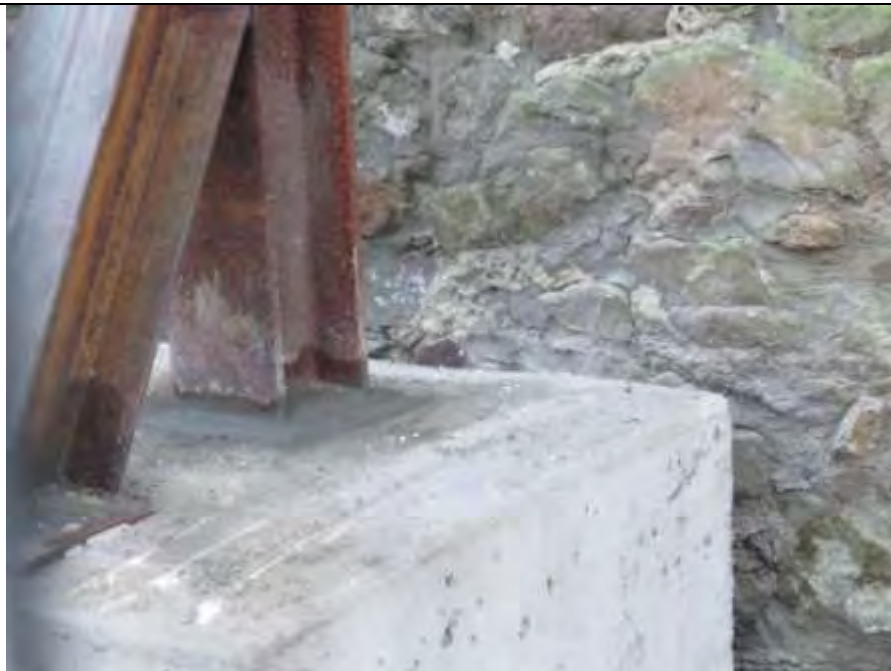
Fig. 22) When all timbers and brackets were in place the main steel stanchion was grouted up.

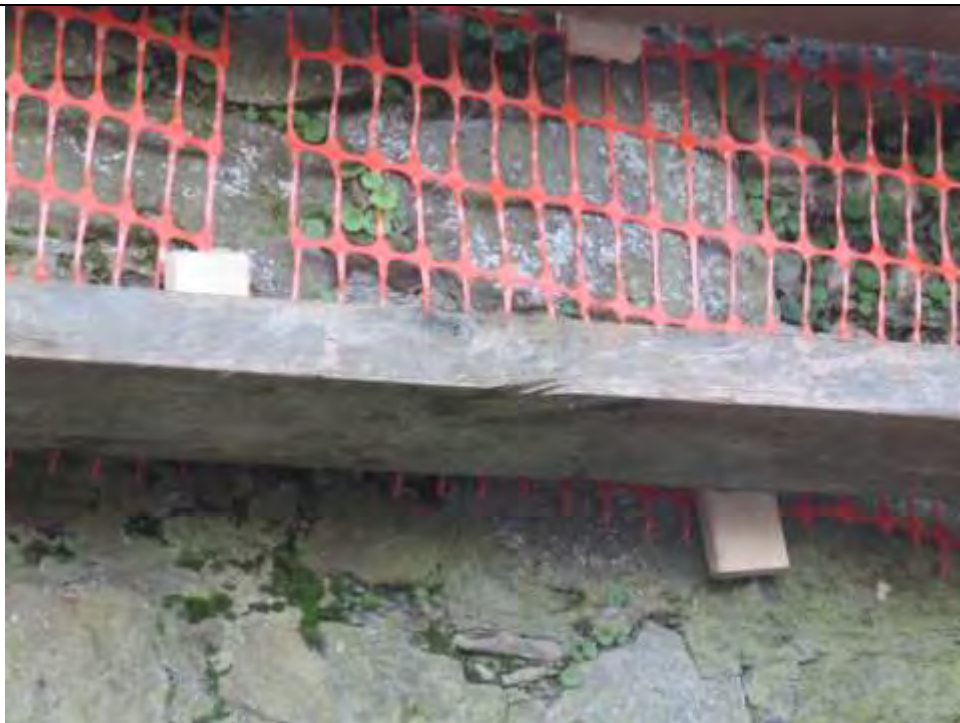
Fig. 24) The top of the wall was covered with an open plastic netting to catch any falling stones and to allow the wall air movement - this picture also shows the wedges in place.

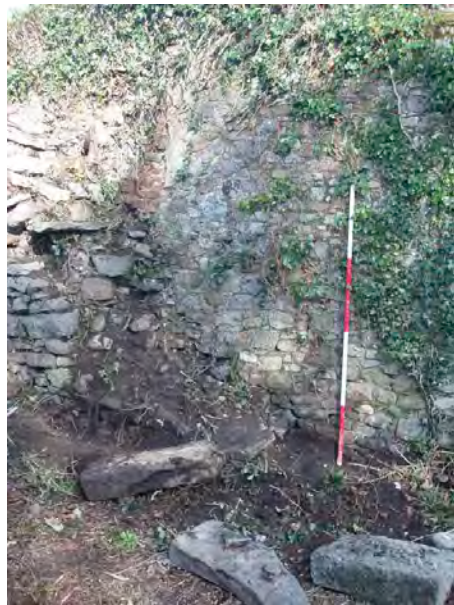
Four steps remain, the lower ones have collapsed. The rise is 350mm, and the masonry here has been invaded by tree roots. Removal of the debris off the lower level exposed a further step, which appears to be a replacement, being very well dressed. This stone is 150mm thick, 700mm in width, and 260mm broad. The wall walk is well constructed, of closely fitted flat stones at the upper level. Several similar stones were located in the rubble piles to the rear of the tennis club.

Plate 4. Wall walk with lowest step uncovered.

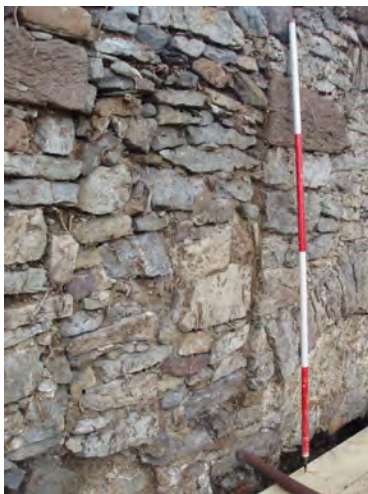
The lower ope, a doorway, has a round headed stone arch of roughly dressed sandstone. The soffit is 1940mm below the top of the wall. The doorway is 1220mm wide, and the quoins are lime mortared sandstone. Clearance of the recent soil at the base of the wall here uncovered a dressed sandstone slab. The wall here, and the masonry fill of the door, is abutted by a barrel-topped buttress. A tall window, with dressed sandstone quoins, is located at the top of the arch. It is 1,800mm high, 940mm in width, and the reveals are not splayed. The fill is roughly coursed mortared stone.

Plate 7. Blocked window ope.

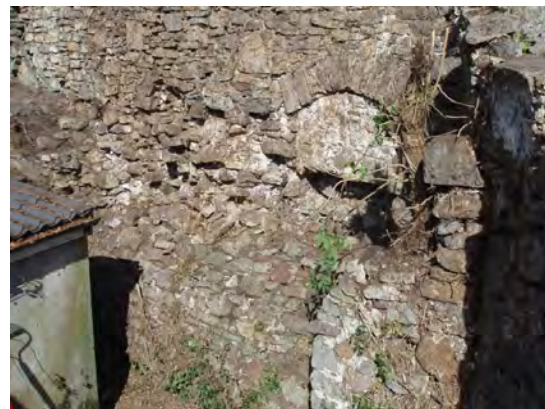
Plate 8. Blocked door ope.

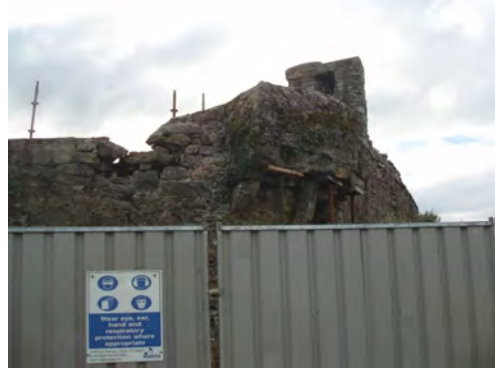
The external wall walk parapet is not bonded to the lower wall, and has been propped.

Plate 14. External view of propped bartizan.

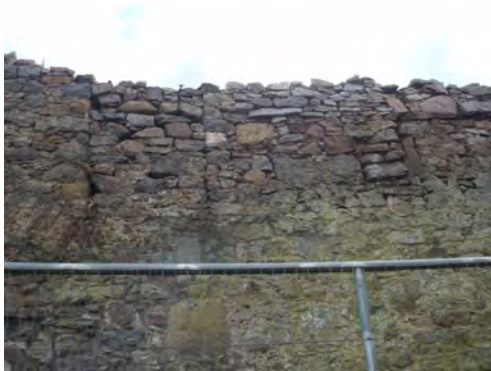
Infilled opes to a building of possible 18<sup>th</sup> century date puncture the northern line of the wall.

Plate 15. North wall, external, blocked opes.

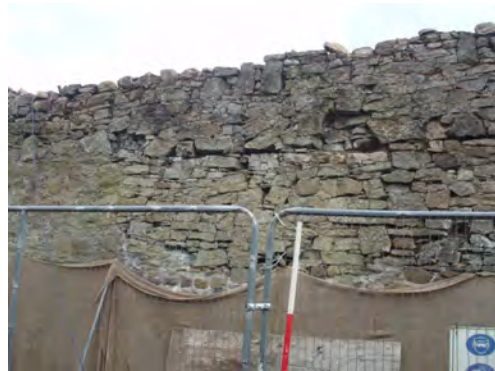
The top of the wall walk inside the northern line of the wall was not accessible, and some of the thin facing stones at the base of the parapet had collapsed due to heavy rain showers. Vertical joints were evident in the parapet kerb. Still further small masonry elements had collapsed recently, and were propped by scaffolding boards.

Plate 16. Horizontal breach along walkway parapet, external, north wall.

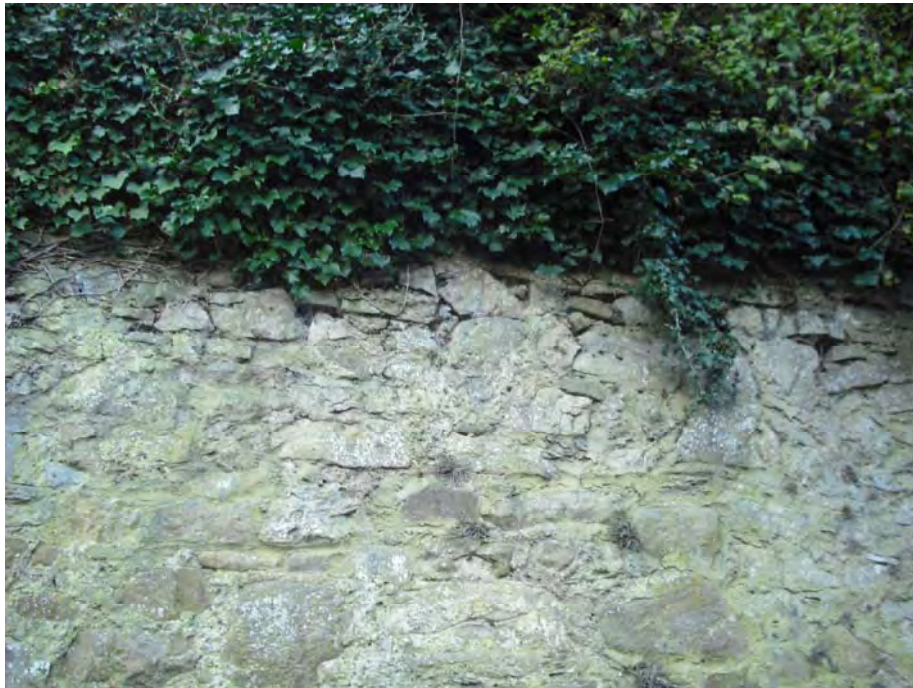
Picture 1 Open Masonry Joints High Level Wall A

*Repointing and stabilizing existing loose stones should be carried out.*

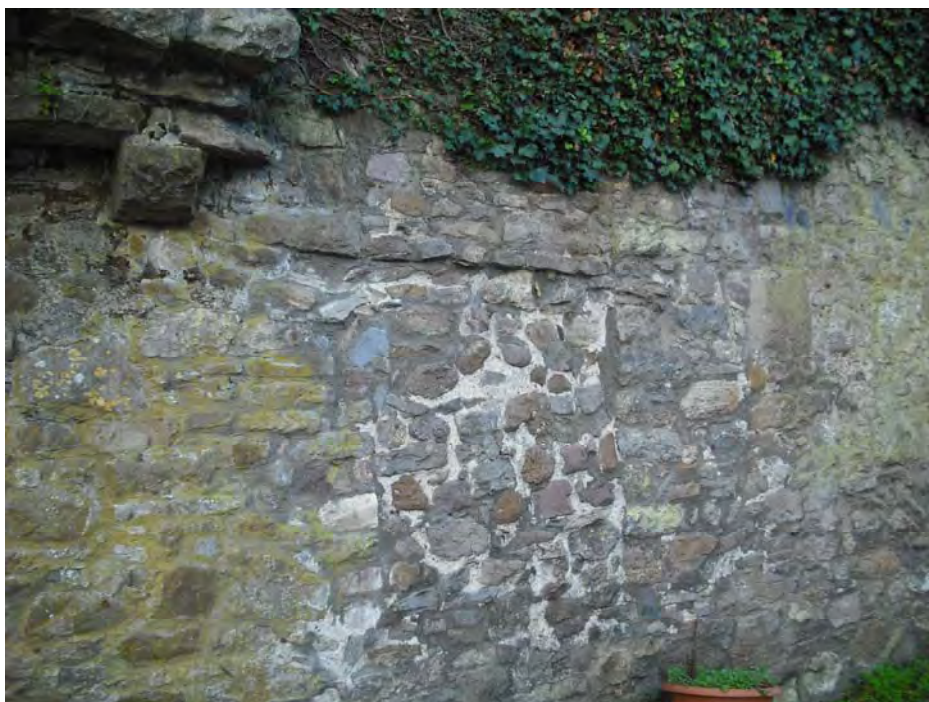
Picture 2 Old Opening Wall A

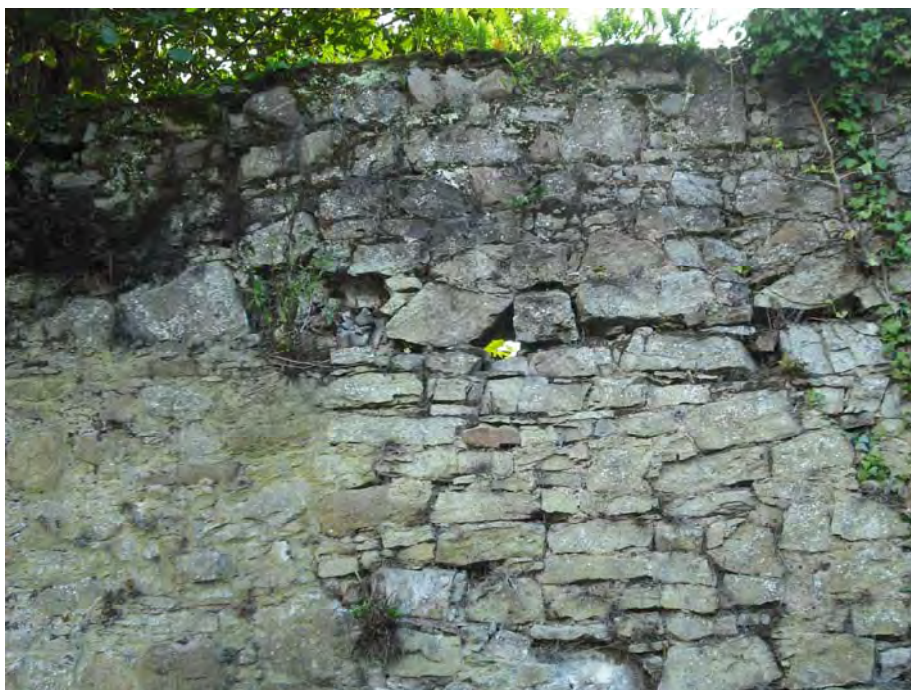
*The narrow wall above this ledge seems from the exposed elements to be generally unstable and in locations has voids that penetrate through the full thickness of the parapet wall, which is about 200-250mm approximately in thickness and even less in places. The vegetation growth (ivy) is causing structural damage. We believe consideration should be given to removing some parts of the top 1.5m high parapet wall together with the vegetation growth. Rebuilding these elements of the parapet wall will require a structural solution to keep it in place.*

Picture 6 Void in Wall A (top 1.5m unstable)

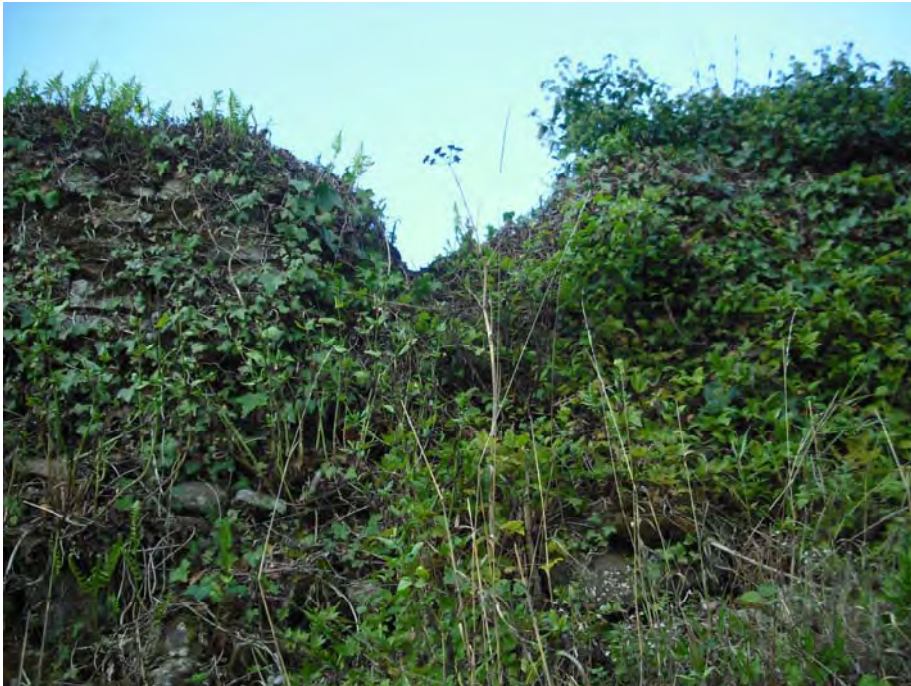
Picture 7 Opening in Wall A Parapet?

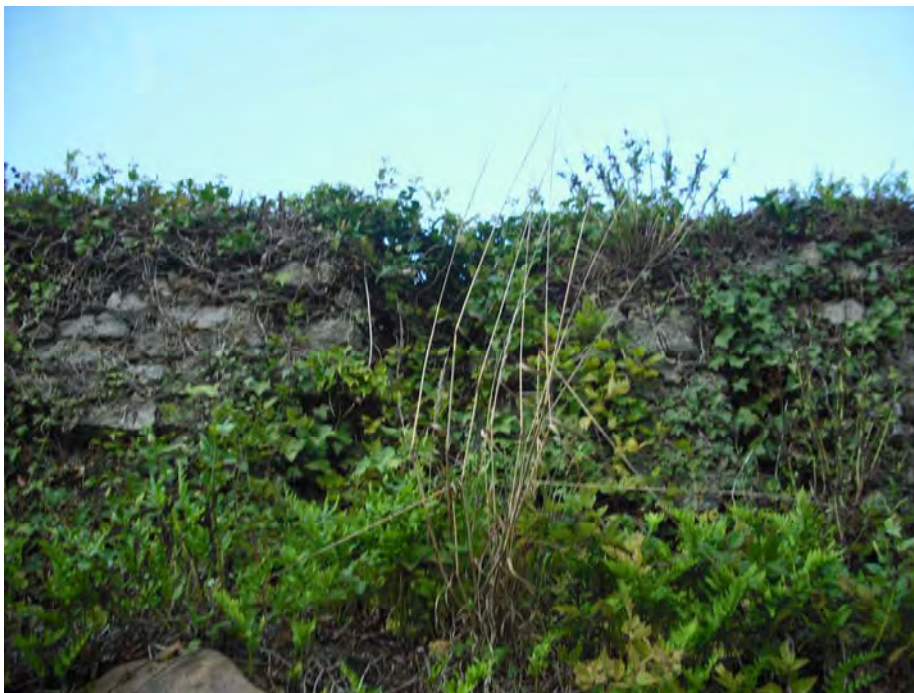
Picture 8 Opening in Wall A Parapet?

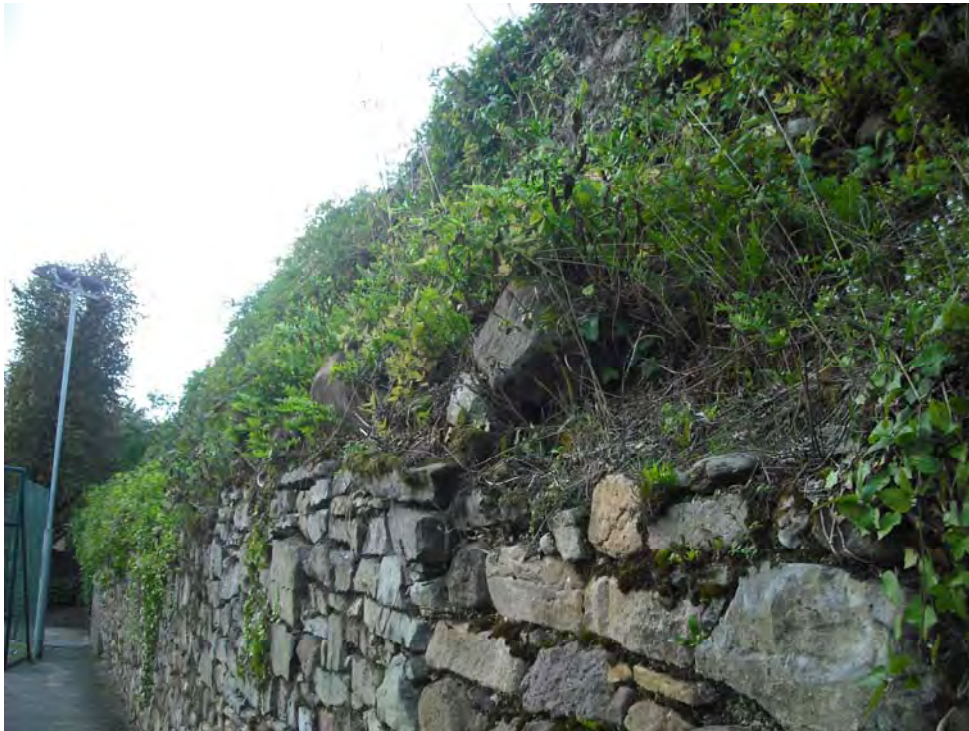
*There are loose stones on the ledge of the wall within the tennis court area. Flaunching in lime mortar of this ledge will be required together with removing vegetation growth.*

Picture 9 Tennis Court Side Loose Random Rubble on Ledge

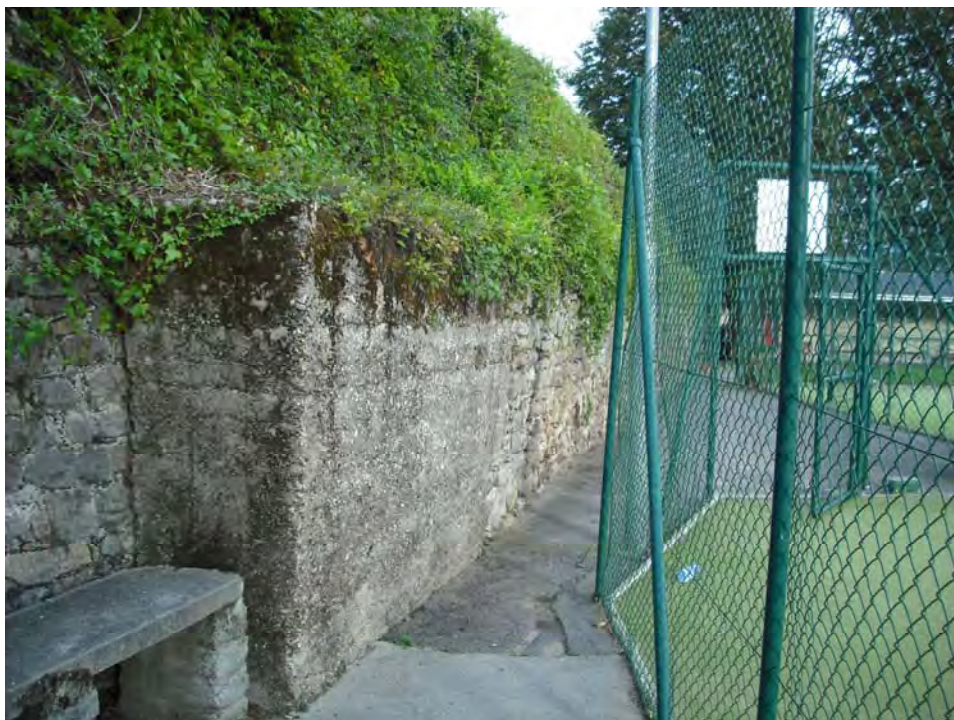
Picture 10 Tennis Court Side Open Concrete Repair Wall A

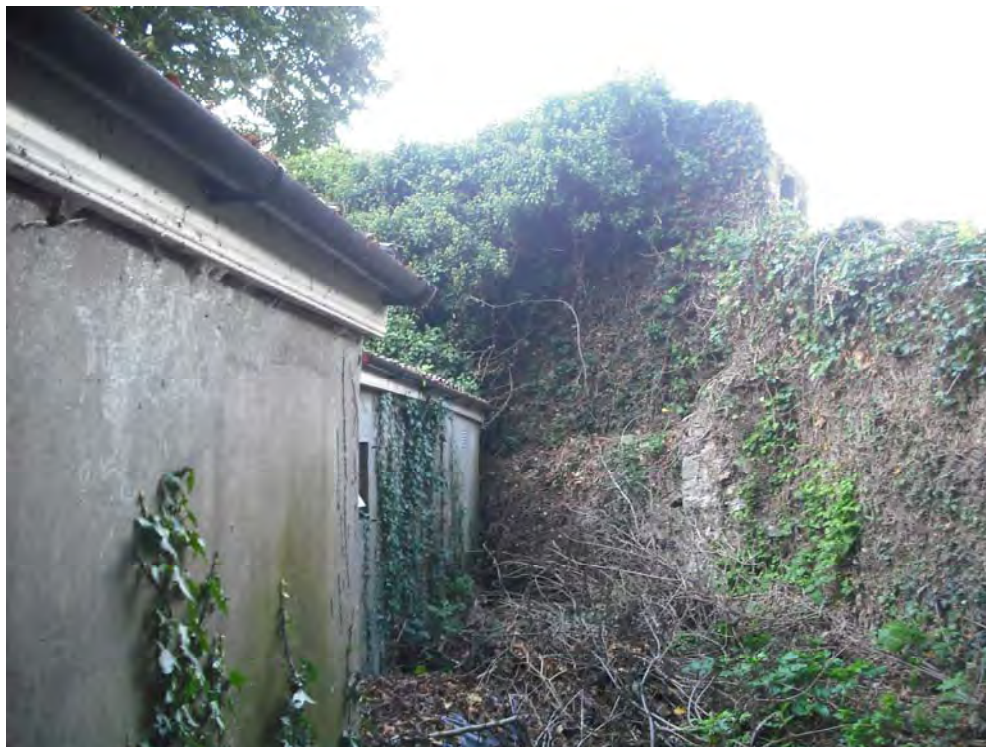
*The wall below the turret has had cracks repaired in the past. The turret itself is missing its own back arm dead weight which in turn puts the wall directly below under some pressure. The turret being on a corner helps the structure somewhat but these old cracks maybe a sign of some overturning due to the turret cantilever having little back-arm.*

Picture 12 Rear of Turret with Club House to the Left
